## **USED ENGINE COLLECTION GUIDE DETAILS**

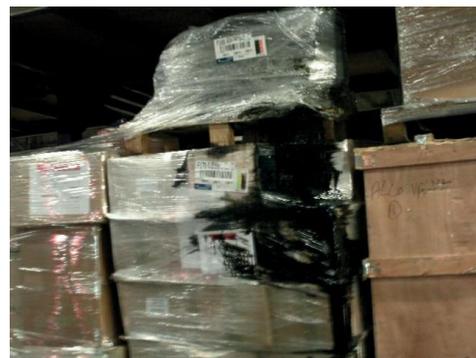
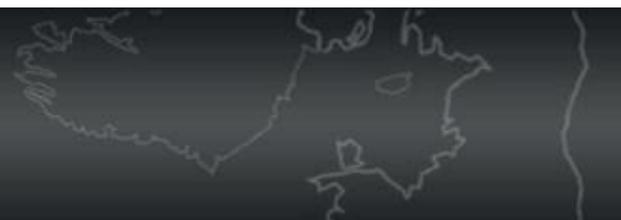
This is what can happen when engines are not shipped correctly!

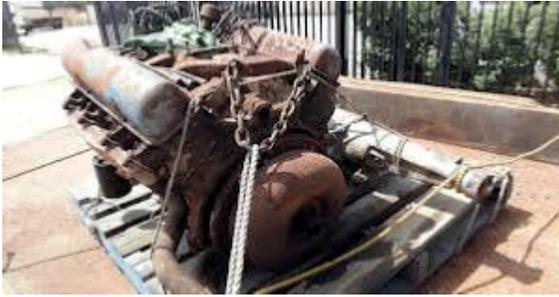
Tied with rope, **not** acceptable.

Fastening to the pallet with ROPE, SHRINK WRAP ONLY, SHRINK WRAP THAT IS NOT SEE-THROUGH EG BLACK, TAPE ONLY, STRAPS THAT ARE NOT RATCHET, OR PLASTIC /METAL BANDS THAT HAVE NOT BEEN AFFIXED BY A MACHINE OR ARE NOT TIGHT, are not acceptable methods for carriage and collection will be refused.

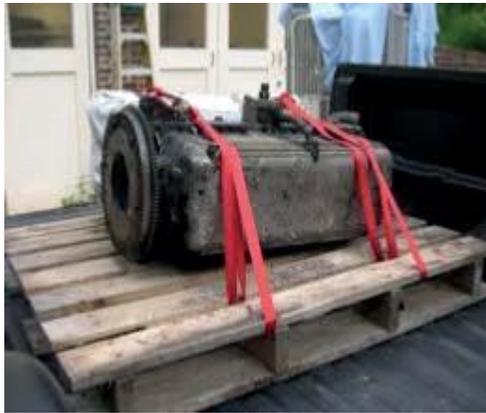
Strapped tightly to the pallet. Ideally should have rags/mats underneath, but it is drained and is a 'clean' engine, it is not wet with oil.

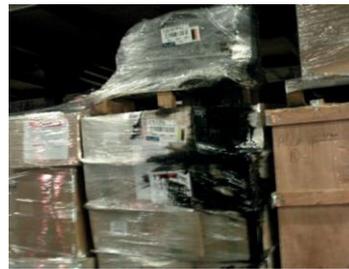
Drained, clean engine, on tyre, good pallet machine banded.

3 If the engine has a sump and is therefore not flat, the sump should be in car tyre to help stabilize it.

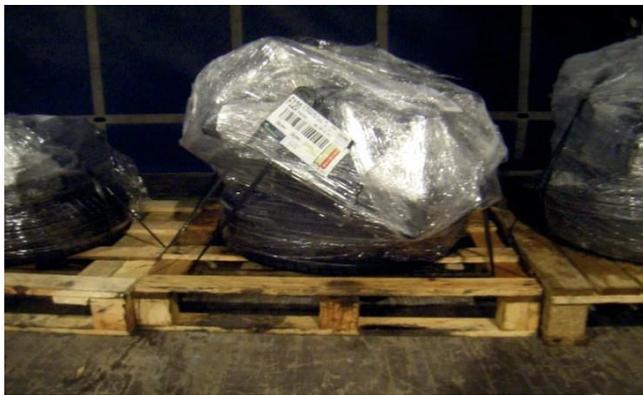
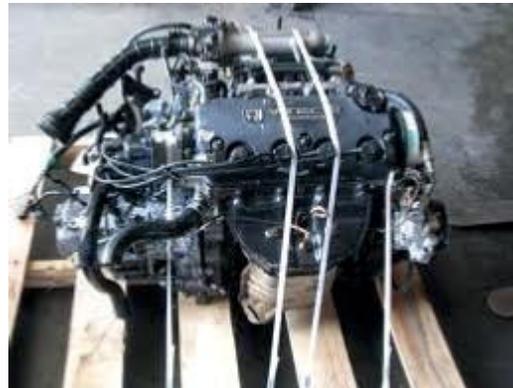
Plastic band strapped engine. 4 plastic straps done by machine and tight. Engine sits flat on pallet, no tyre needed. Ideally should be sat on rags/mat, but not needed as engine is drained, and is very clean. Straps could benefit from protection, but if bands touch smooth areas then are ok.
